Keg impact damage to fibre-reinforced paving flags

D. Sinnott MSc, MIEI and R. P. West MSc, DIC, PhD, MICT, CEng, FIEI

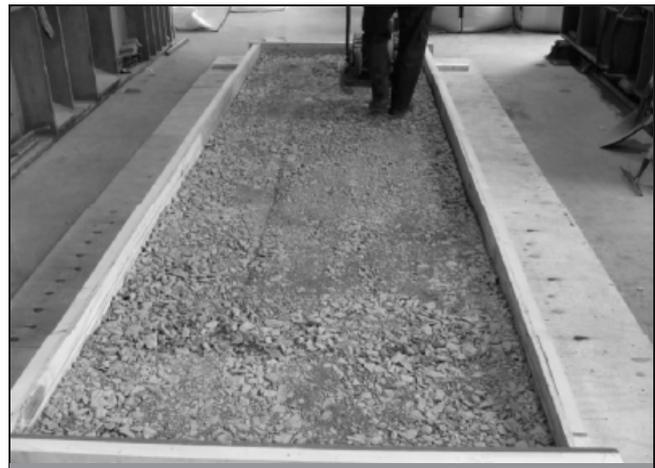
Several model pavements were assembled (Figures 8 and 9) for multiple impact and static testing. The subbase comprised a clause 804 aggregate¹⁸ of 15 cm thickness, with a coarse sand

Figure 8. Compacting subgrade of model pavement

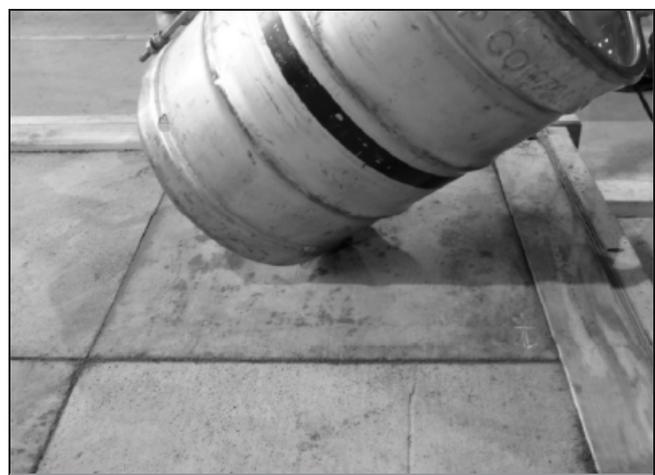
Figure 9. Impact of beer keg at 45° onto centre of paving flag

The impact load was induced by an aluminium keg of dimensions 53.5 cm high and 42.0 cm in diameter, weighing 62 kg. Free drop heights under gravity varied from 0.25 m to 1.5 m in increments of 0.25 m. The keg orientation on impact was either vertical, horizontal or at a 45° angle. The orientation was fixed using a special bar sliding mechanism and a quick-release Bowden cable system.¹⁹

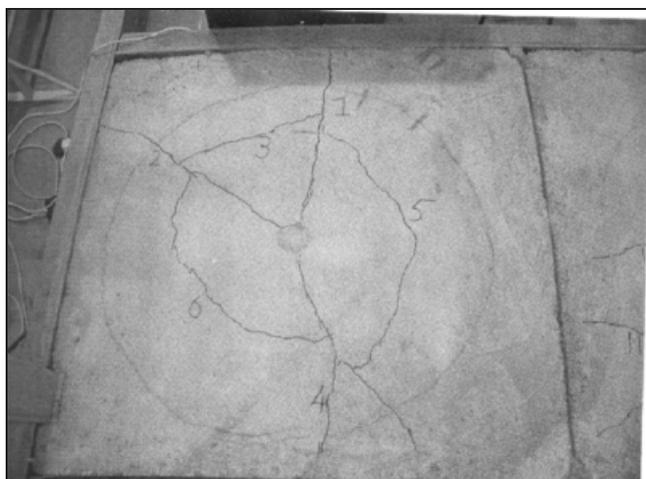
With a drop height of 1.5 m at the most damaging orientation of 45° and a slab size of 1.75 m square with 70 mm depth, circumferential cracks were developed under repeated impacts (Figure 11). The diameter of the actual circular cracks ranged from 315 mm (SFRC) to 610 mm (plain RC), which compared reasonably well with the predicted diameter of 470 mm using

Figure 11. Circumferential crack due to hogging moments on wider slab impact test²¹

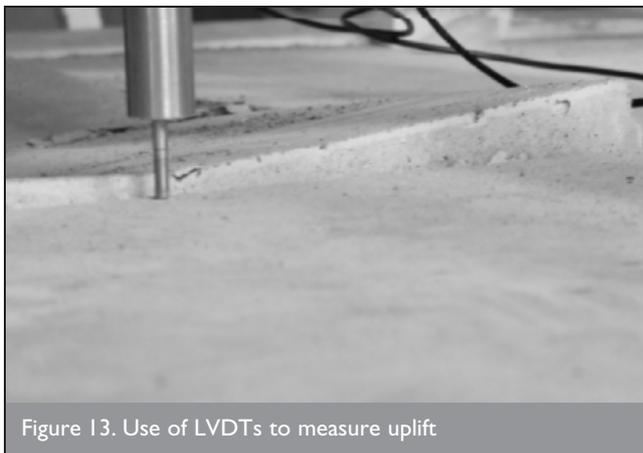
Figure 13. Use of LVDTs to measure uplift

A post-cracking static load of 40 kN, representing a standard axle load of a commercial vehicle, was applied to each flag in turn using a mobile test frame (Figure 12). The steel reaction rig allowed a monotonic force of up to 48 kN to be applied to a cracked flag, where reaction was provided through large bags of aggregate placed in two demountable skips on top of the steel frame, acting as kentledge. Load was applied using a 100 kN servo-controlled actuator in displacement control mode¹⁴ at a rate of 4×10^{-6} m/s through a $6.0 \times 6.0 \times 2.0$ cm steel plate. A calibrated load cell and a number of linear variable differential transformer (LVDT) transducers were used to monitor the load and displacements, respectively, including the uplift at the flag's corners and in adjacent flags (Figure 13).
