# Steel fibre combined with conventional reinforcing Joint Free Spillway Chute – Key elements for durability and serviceability

Tian Sing Ng<sup>1</sup> & David Gardiner<sup>2</sup>

<sup>1</sup>Engineering Manager, BOSFA

<sup>2</sup>Principal Engineer, SMEC Australia

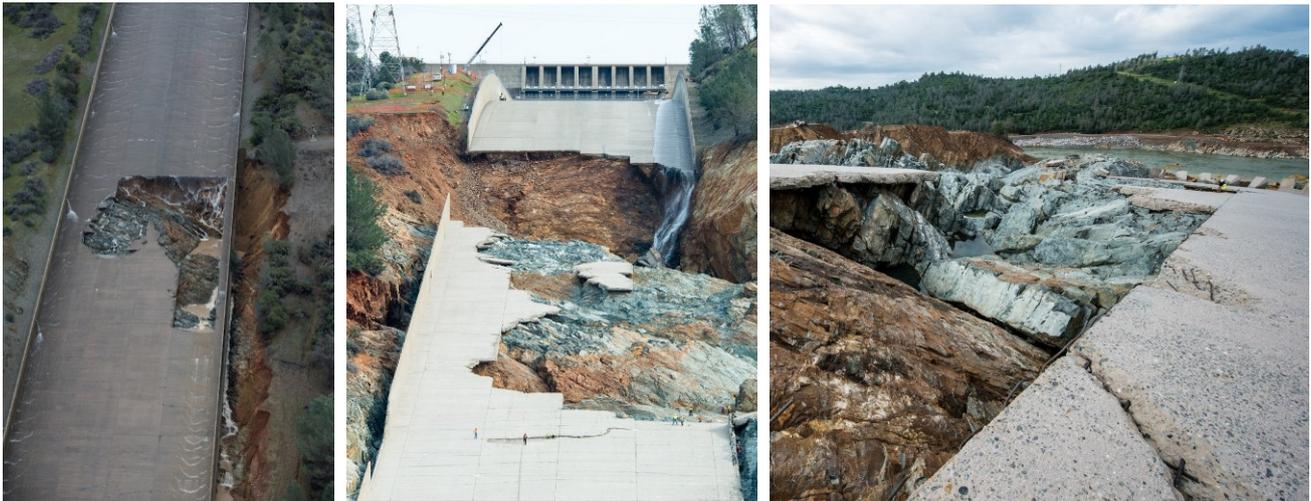
*Figure 3. Structural collapse of Oroville spillway; note the failure through joints.*

As shown in Figure 3, the spillway chute has failed at the joints, which appear to be the weakest section.

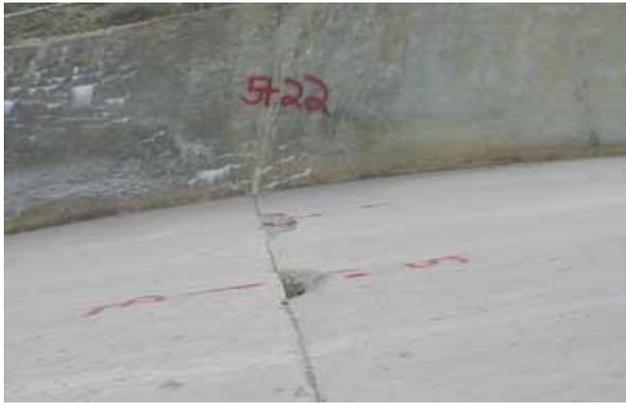
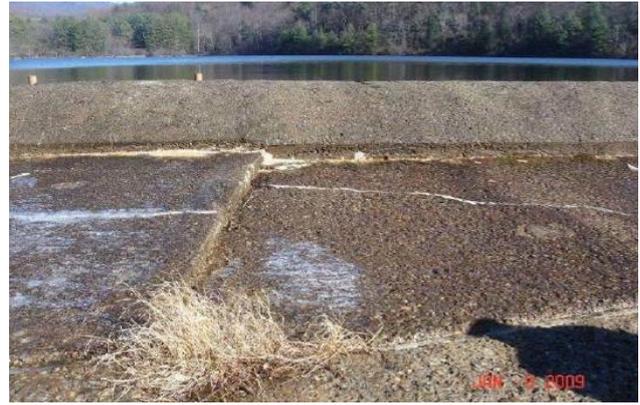
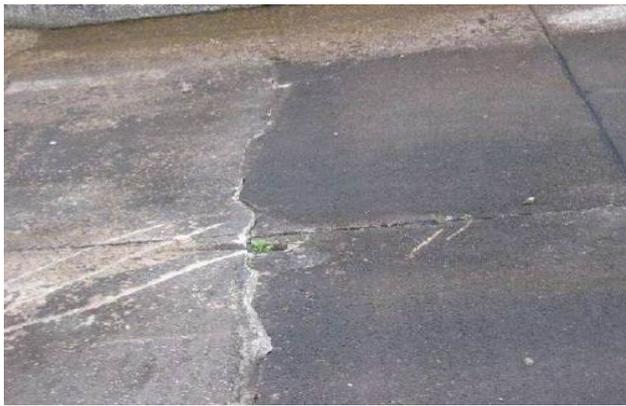
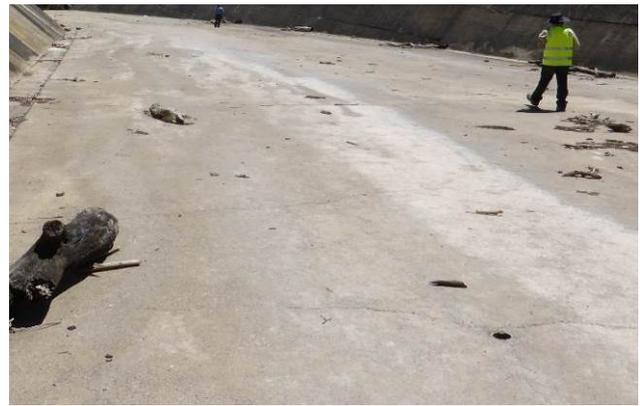
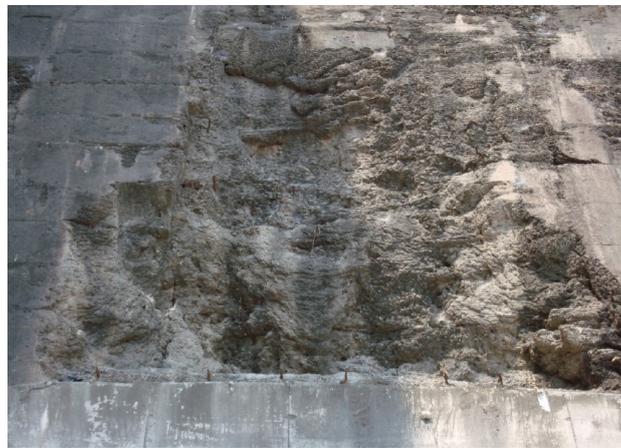
**Figure 4. Typical deficiencies in spillway: (a) Spalling of the spillway joint at Scofield Dam USA (Trojanowski, 2008); (b) Offset spillway joint at Stoney Creek Dam USA (Paxson & Young, 2010); (c) Cracked spillway at Colyer Lake Dam USA (Paxson & Young, 2010); (d) Restrained open cracks between joints at an Australian Dam; (e) Cavitation damage at Nagarjuna Sagar Dam India.**

Defective joints and open cracks are the Achilles' heel in spillway chutes. Joints in spillway chutes can work effectively, if detailed and constructed properly, but may require on-going maintenance. Figure 4 presents some typical spillway chute deficiencies mainly due to joints and open cracks. Being able to minimise or eliminate joints and open cracks is an attractive proposition in terms of dam safety and obviously the dam owner's on-going maintenance costs.

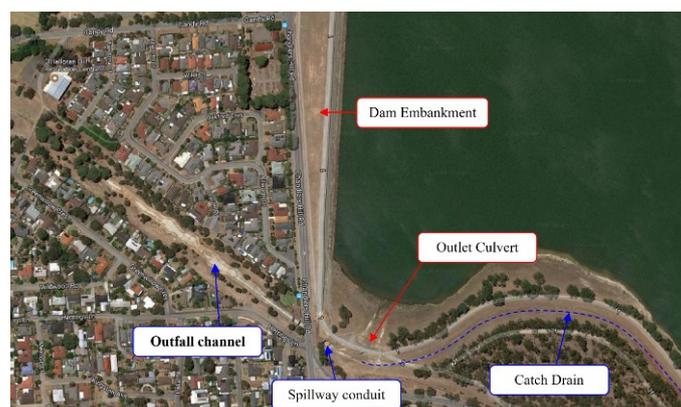
Figure 8. Site location.

The Happy Valley outfall channel was an unlined cut through natural soils and rock extending from the southern abutment of the Happy Valley Reservoir. The channel is an extension of the catch drain around the reservoir, and doubles as a spillway in times of flood as shown in Figure 8. The channel is steeply inclined. Vertical alignment is not uniform, being 3% in the upstream, steepening to 8.5% in the central section and flattening to 3% at the downstream end.

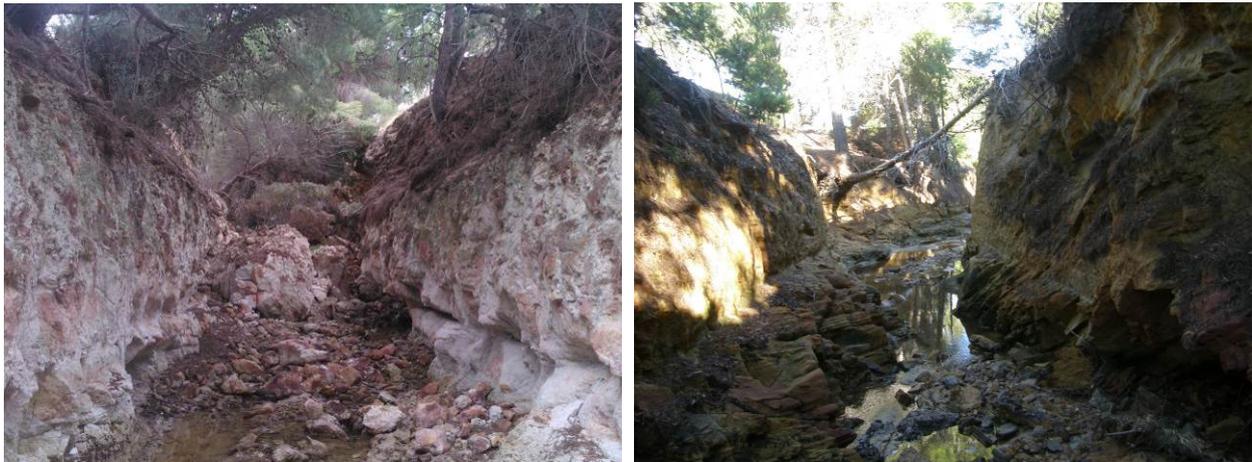
**Figure 9. Condition of dam spillway outfall channel prior to remediation work.**

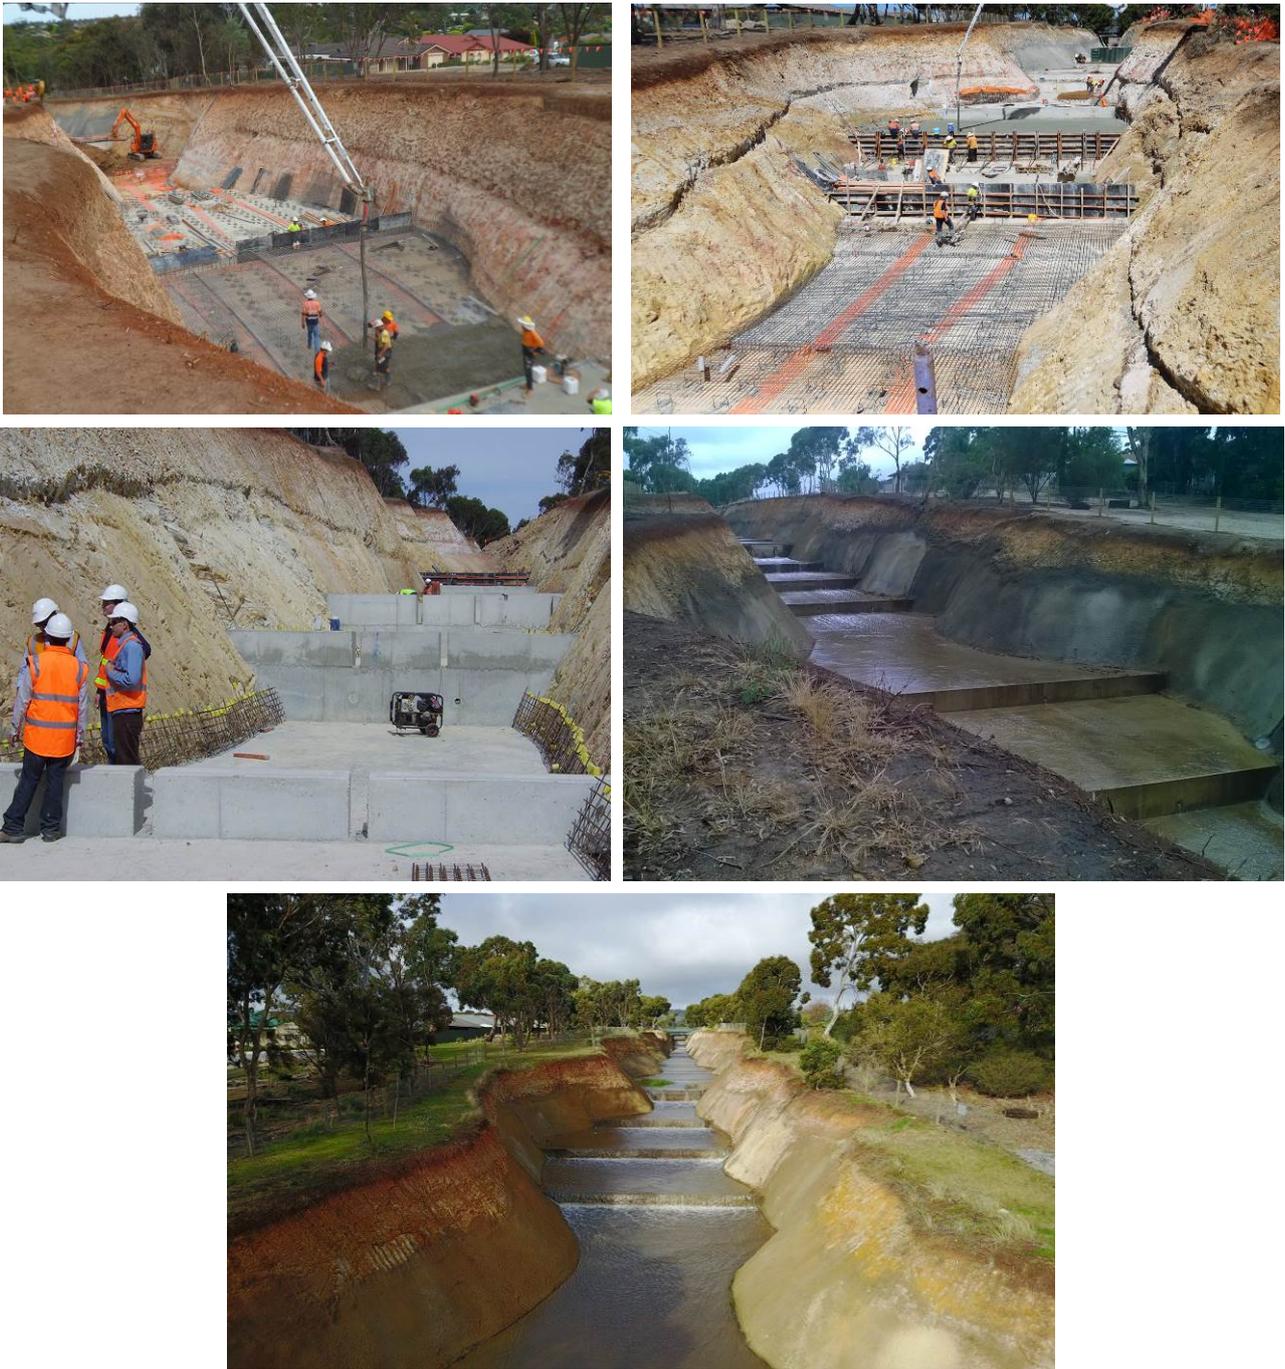
*Figure 11. SFRC combined with conventional reinforcing joint free Happy Valley Dam Outfall Channel, Australia.*

Due to the cut-offs, drop structures and the geometrical and shape (varying width) of the channel, the spillway channel chute was assumed to be fully restrained (Figure 11). Taking this restraint into account in the design through combining SFRC with one layer of N12 at 100 mm spacing custom-made steel mesh, enabled the construction of the floor without any joints for the entire 400 m length with a design nominal crack width of 0.20 mm. There were no limits on the time between adjacent slab pours or between the time that the floor had been poured and the walls being constructed. This solution was economically beneficial when compared to the conventional design which used 2 layers of N28-150 bars and the installation of expansion and control joints requiring dowels, waterstops and sealants.

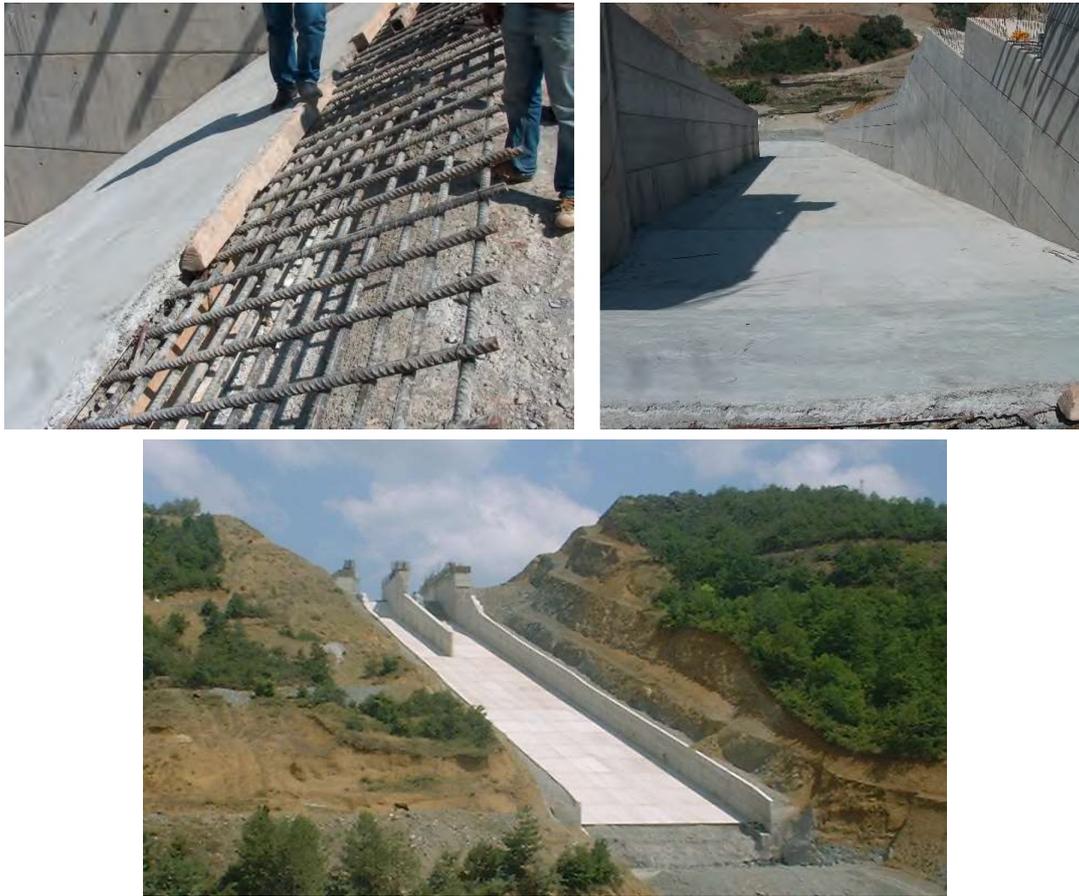
*Figure 12. SFRC combined with conventional reinforcing joint free Koprubasi Dam Spillway, Turkey*

Constructed in 2008 for the Turkish General Directorate of State Hydraulic Works, this joint-free watertight spillway (Figure 12) is 500 mm thick and totally joint free. The conventional design used 2 layers of heavy reinforcing bars, closely spaced and was very expensive with a complex jointing system. In addition, the steepness of the spillway posed significant challenge in placing the heavy reinforcement and joints during construction. The SFRC option was adopted in combination with much lighter reinforcement, which resulted in a solution that was cost effective, joint free, more durable and quicker and easier to build.

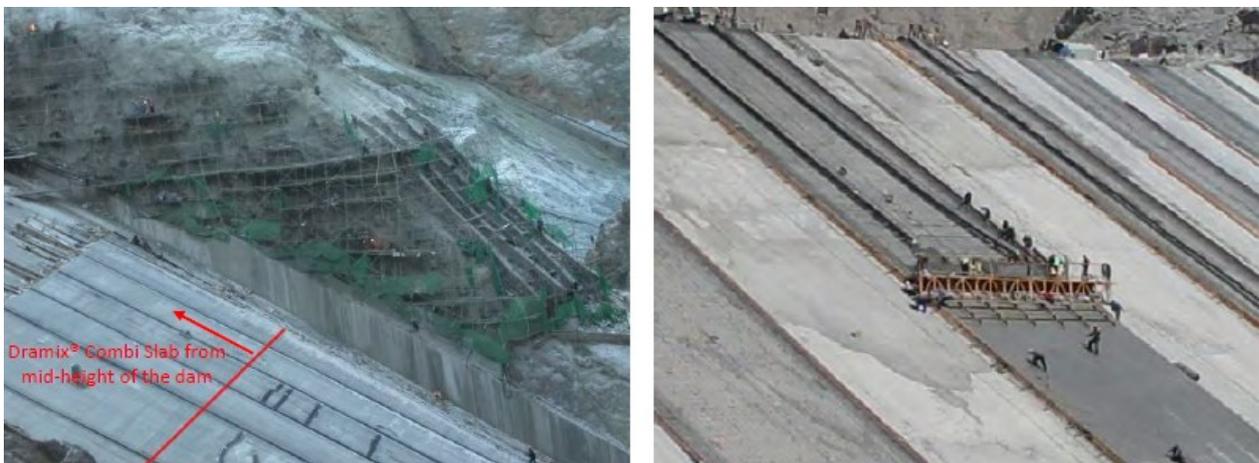
*Figure 13. SFRC combined with conventional reinforcing system for Longshou II CFRD face slab, China.*

While the primary focus of this paper is spillway design; a SFRC combined with conventional reinforcing joint free system was also adopted for the upstream face of the Longshou II Dam concrete slab. The dam is a 146.5 m high concrete faced rockfill dam, located in a high seismic zone. The valley is asymmetrical, with a width to height ratio of 1:1.3. The climate is extreme, with a wide range of temperature variation between day and night. Because of the unique topographical conditions, the face slab is subject to high tensile stresses. The original design with conventional reinforcement exhibited cracking to an unacceptable level during construction. Soon after this occurred, a SFRC combined with conventional reinforcing system was adopted for the top 75 m of the dam. The target of crack control was fully achieved. To-date, it is still performing extremely well even after experiencing at least two major earthquakes (Zhou and Zhang, 2005; Lu, 2008; Yang et al., 2008).
